SAMPLE PLAN DOCUMENT

MAIN STREET DAM REMOVAL & SCIOTO GREENWAYS

FEASIBILITY STUDY

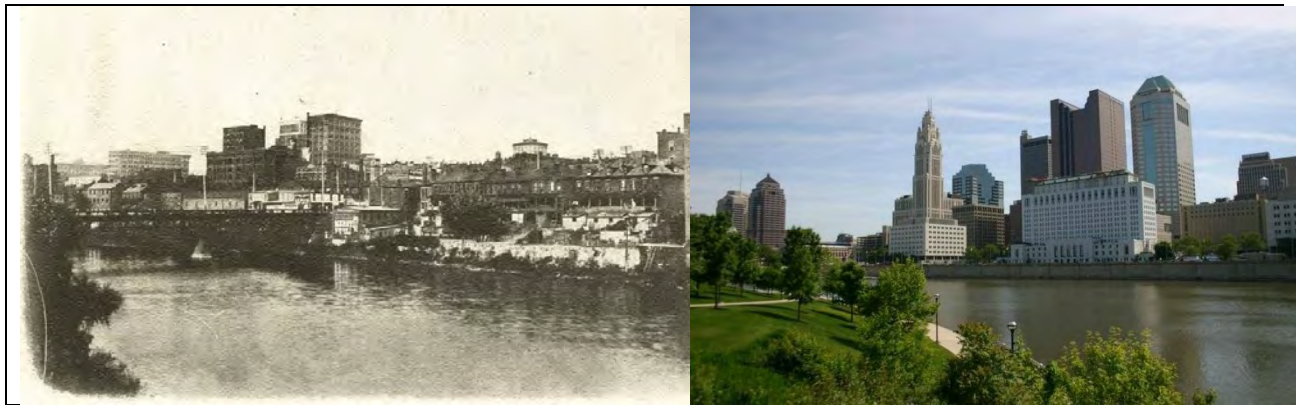
Figure 1-1. Scioto River Looking Northeast in 1906 (left) & 2011 (right).

The Main Street Dam is located on the Scioto River approximately 1.2 miles downstream of the confluence with the Olentangy River in downtown Columbus, Ohio. The pool created by the dam extends upstream through downtown Columbus for approximately 2.3 miles to the Dublin Road Low Head Dam. The dam was initially constructed as a timber structure in the mid 1800's to provide water to the feeder canal for the Ohio-to-Erie Canal. After the flood of 1913 destroyed the timber dam, it was rebuilt as a concrete structure in 1921, and then raised in 1929 to its current height.

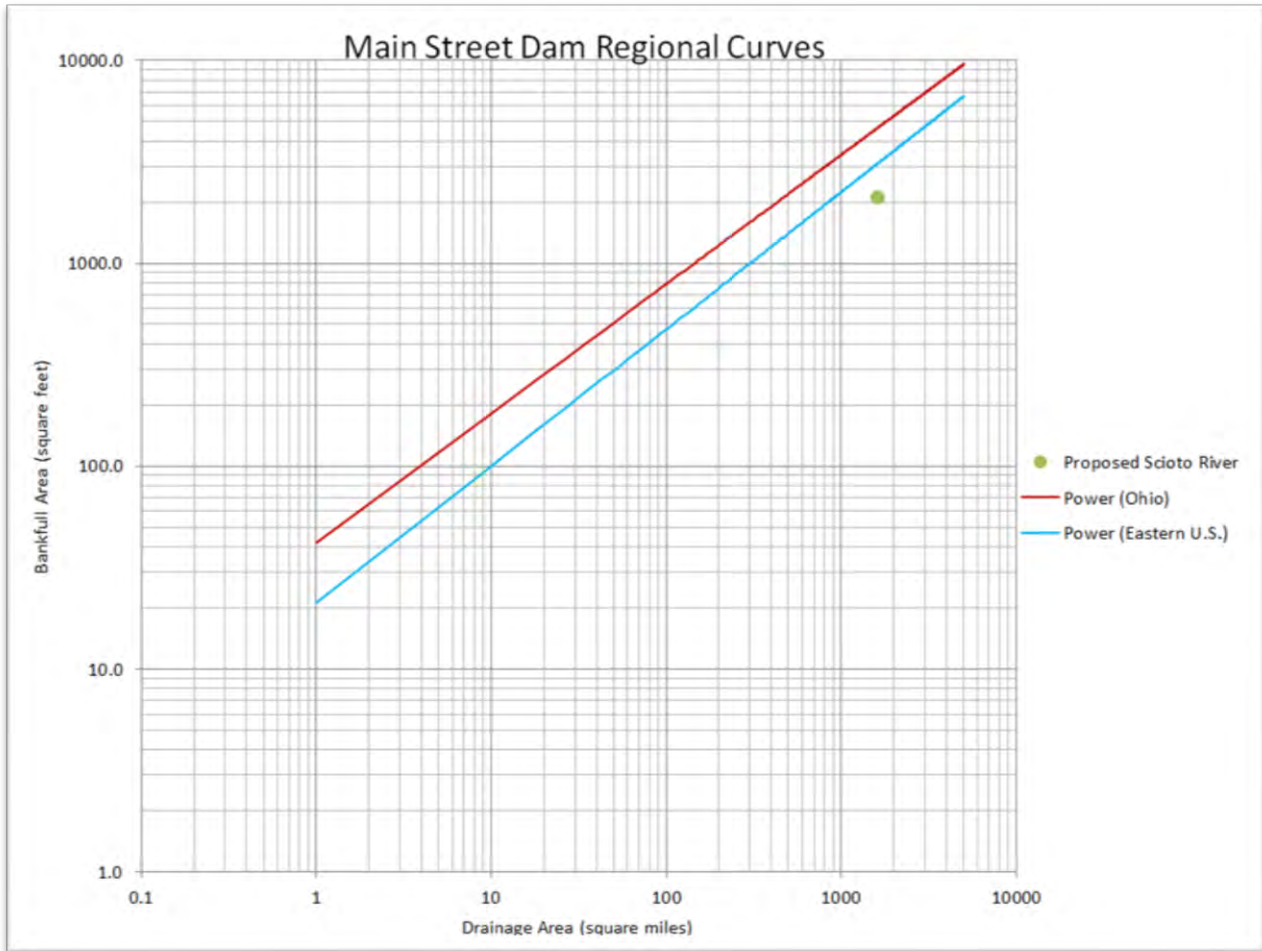
Figure 6-1. Regional Curve

The preliminary, proposed cross section used for this study is a multi-stage channel utilizing a low flow, inner berm stage and a bankfull stage. The inner berm feature is a dynamic feature, while the bankfull stage is more stable from event to event. Figure 6-1 shows the preliminary, proposed bankfull cross sectional area as compared to regional curve data. Since regional curve data is based on natural streams and the Scioto River has been modified by extensive anthropogenic changes, a bankfull cross sectional area slightly below the regional curve trend lines was selected to account for the increase in flood storage provided by the multiple reservoirs located upstream of the project site. Published regional relationships for inner berm features are not currently known to exist. Therefore, it is up to the designer to field verify the data related to this feature, typically through reference reach surveys, which are discussed in the following section.

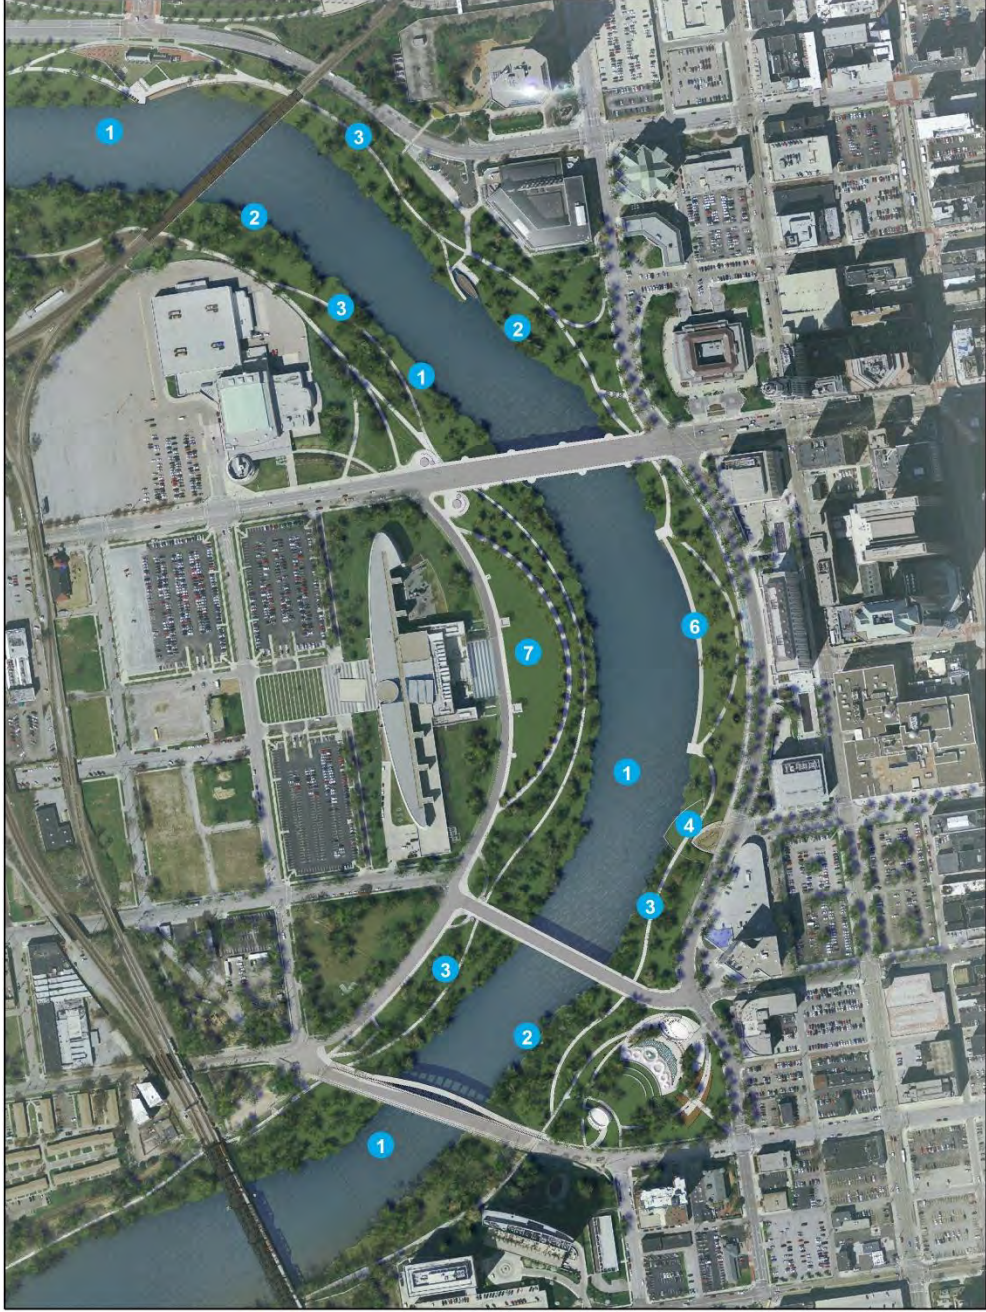
Figure 6-2. Phase I Concept Rendering

Phase One Elements (Numbers correspond to Figures 6-2 and 6-4)

6. Scioto Quay: Lower level walkway along river's edge with space for seating, strolling and events. The quay brings people to the river, provides a link in the trail system, and forms part of the East Landing.

7. Event Plaza and Lawn: Extension of the plaza and lawn space in front of COSI to create a venue for expanded festivals, events and exhibits.

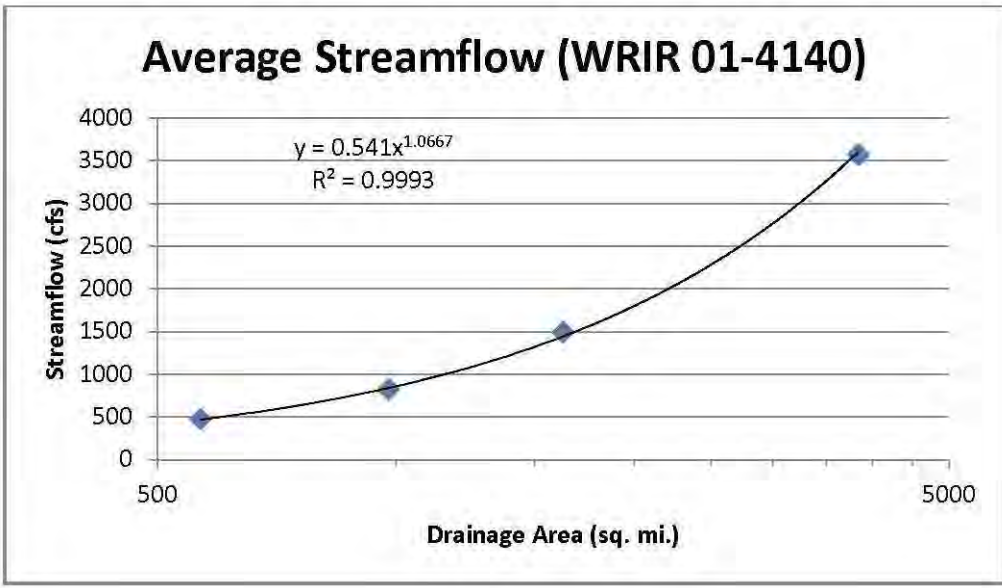
Figure 7-1. Average Streamflow Drainage Area Weighting Procedure

The equation used to weight the flow for the un-gaged sites on the Scioto River are illustrated in Figure 7-1.

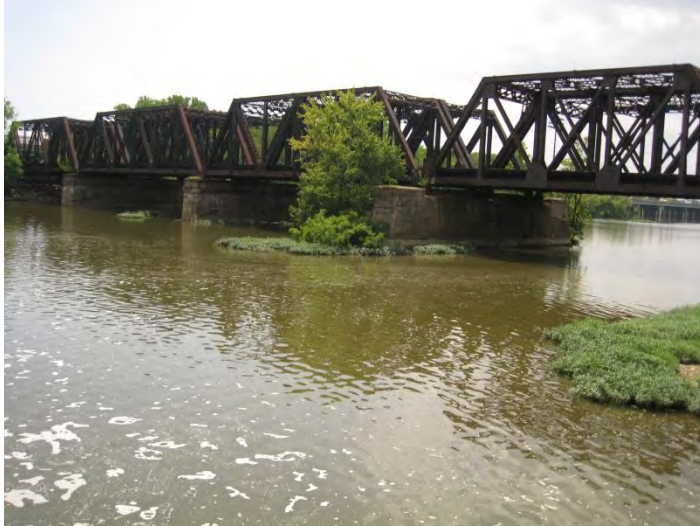
Photo 8-1. NS/CSX Bridge showing aggradation at pier

This shared railroad bridge is actually two bridges on common piers. The east bridge is used by Norfolk Southern and the west bridge by CSX. The combined structure is 70 feet wide by 590 feet long and was constructed to its present condition in 1919. The record plans for the bridge

are shown on Exhibits 4 through 6 in Appendix H. The abutments and piers are supported on separate footings at elevation 684 (estimated from record plans) with piling tipped at an unknown elevation.

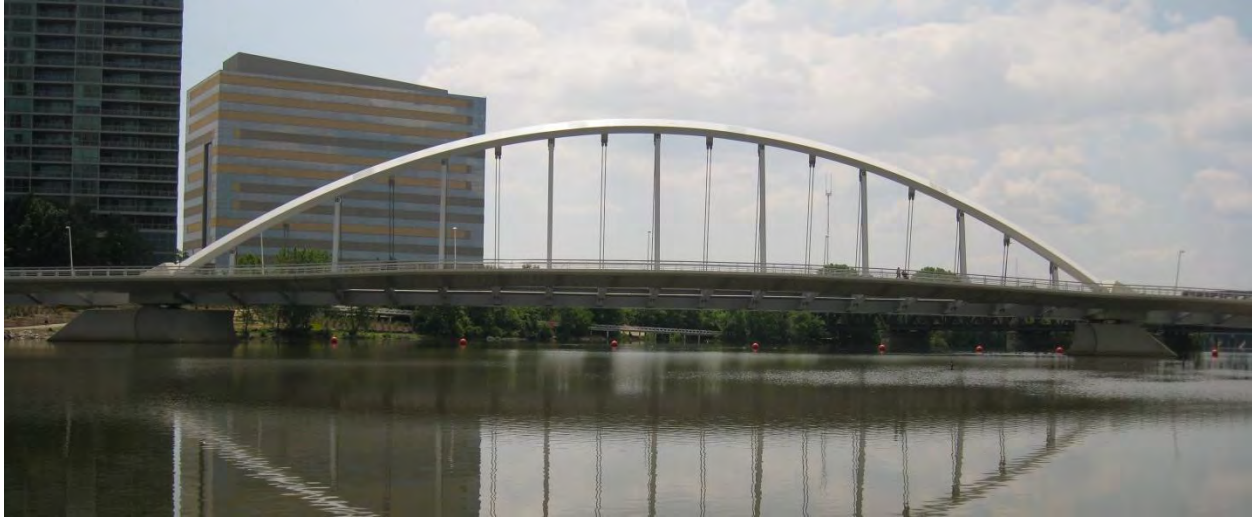
Photo 8-2. Main Street Bridge (looking south)

The Main Street Bridge is located approximately 370 feet upstream of the Main Street Bridge. The bridge is shown in Photo 8-2.

Record plans from the City of Columbus, Transportation Division show that in 2011, the existing seven span, reinforced concrete, open spandrel barrel arch bridge was replaced with a three span, inclined arch bridge on a reinforced concrete substructure. Selected record plans are provided as Exhibits 7 through 9 in Appendix H.

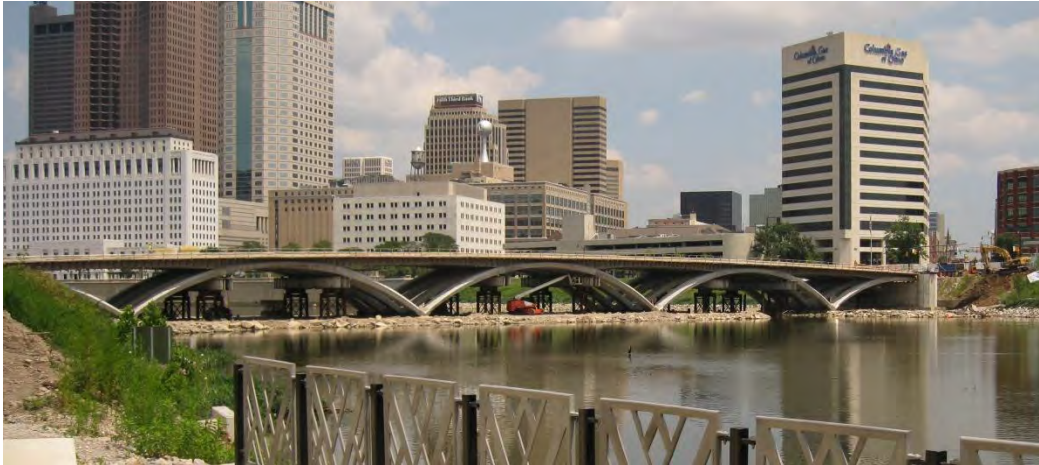
Photo 8-3. Rich Street Bridge looking north

The Rich Street Bridge is 60 feet wide, 562 feet long and is located approximately 1,075 feet upstream of the Main Street Dam. The bridge is shown in Photo 8-3.

Per record plan information, pier caps are set on 5.5-foot-diameter drilled shafts, which are set 3 feet, minimum, into limestone bedrock (approximately elevation 634). The bottom of the pier caps are at elevation 700.90. The bottom of the abutment footings are at elevation 702.5 and 704.0. The abutment footings are founded on HP 12x74 steel piles, 55-60 feet long.

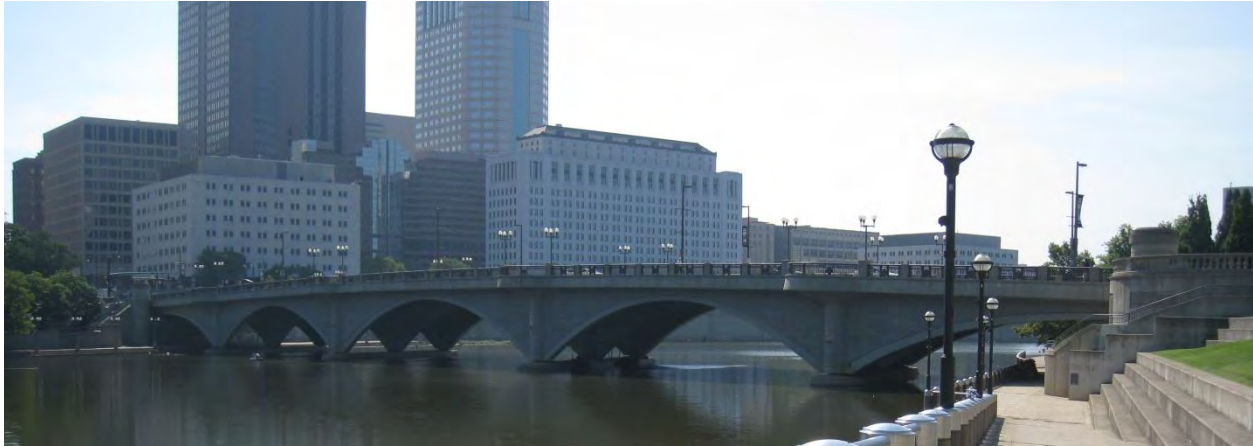
Photo 8-4. Broad Street Bridge looking south

The Broad Street Bridge is 100 feet wide and 660 feet long and was constructed in 1990. The bridge is located approximately 2,700 feet upstream of the Main Street Dam. Photo 8-4 shows the bridge. Record plans are shown as Exhibits 12 and 13 in Appendix H.

Pier caps are set on 7 foot diameter drilled shafts, which are set a minimum of 3 feet into limestone bedrock (approximately elevation 630). The bottom of the pier caps are at elevation 700.0. The bottom of the abutment footings are at elevation 695.0 and are founded on HP 14x73 piles with an average length of 65 feet.

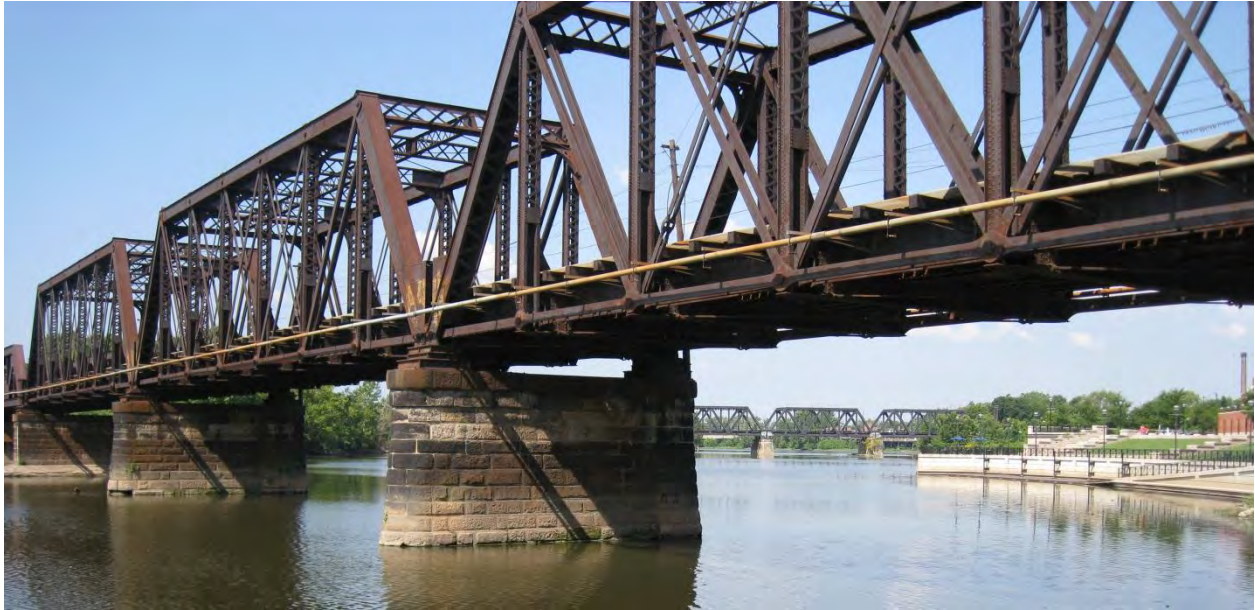
Photo 8-5. Norfolk Southern and CSX Bridges (looking north)

The Norfolk Southern Railroad Bridge was built in two phases. The first phase was constructed in 1903 and includes the three truss spans. The second phase was constructed in 1921 and includes the two pony truss spans. The bridge is 31 feet wide and 670 feet long. Photo 8-5 shows the Norfolk Southern bridge in the foreground and the CSX bridge in the background. Selected record plans are shown as Exhibits 14 through 16 in Appendix H.

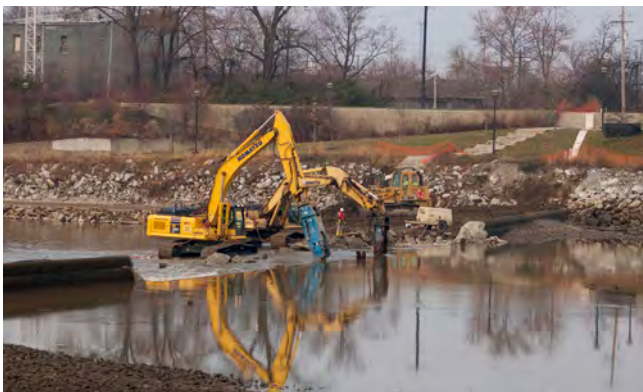
The Main Street Dam was breached in November 2013.

- The dam had significantly altered the natural channel of the Scioto River.
- The dam impounded approximately 2.3 miles of the Scioto River impeding the flow and damaging the river habitat.
- The dam inhibited the river from reaching its full potential as a warm water habitat, removing it would have a positive impact on the aquatic habitat, improving the river's health and water quality.
- The removal of the dam and subsequent river restoration would increase the diversity of the native fish and mussel species within the affected segment of the Scioto River.

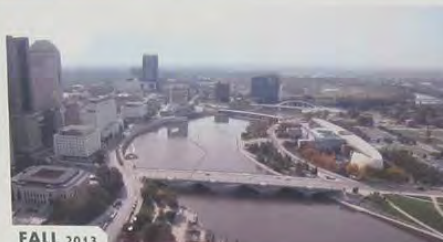
FALL 2013

- Width of river creates barrier between Downtown Columbus and Franklinton and stagnant water inhibits riparian ecosystem

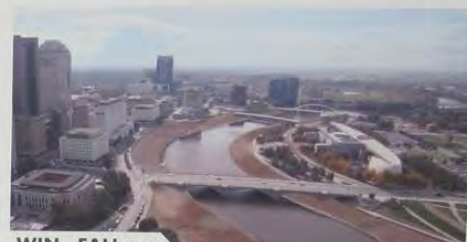
WIN - FALL 2014

- River channel is excavated and river is narrowed to approx. 300 ft.
- New river banks are constructed

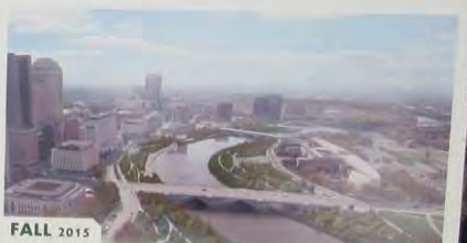
WIN - SPR 2015

- New shared bike and pedestrian paths are constructed
- Electric and irrigation systems are installed throughout project area

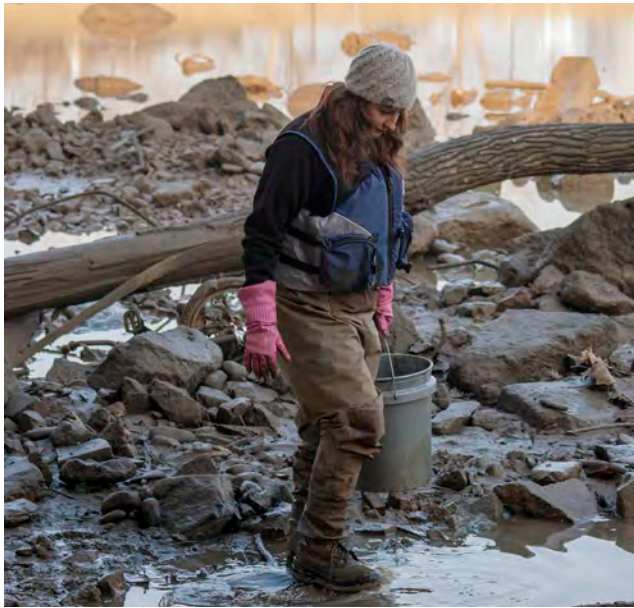
Dam breach protocol for the removal of the Main Street Dam was established to provide safe working conditions during demolition, to minimize the mobilization and transport of large volumes of sediment, and to support an upstream freshwater mussel rescue and relocation effort. Approximately 4,500 common, live freshwater mussels were rescued along the newly exposed banks and relocated during the drawdown once the dam was breached. Teams of biologists from Stantec, along with volunteers from various agencies such as ODNR, OEPA and ODOT, the Ohio State University, and local watershed groups made the rescue successful in a very tight timeframe at the end of November and the beginning of December 2013.

Rescuing mussels after the dam breach

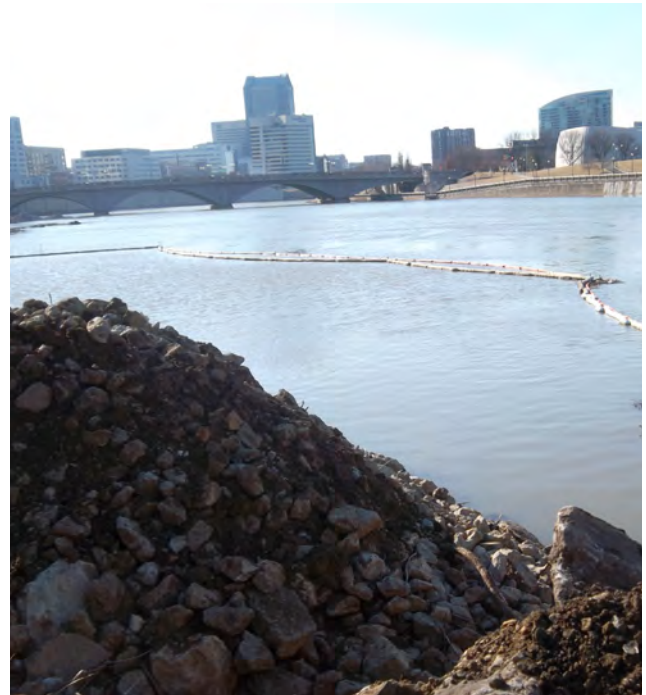
During construction, an area of contaminated sediments was discovered in an area that was previously underwater, but was designed to be within the new river banks. The team quickly mobilized to contain the area and map the extents of the contamination. Luckily, it was a very small area and could be easily worked around while coordinating with OEPA on a mitigation plan. Historical research found that the Standard Chain Company previously occupied the area before the dam was built and impounded water over the site. The area was successfully mitigated per an approved plan with OEPA, and the construction schedule was not adversely impacted.

Containment booms installed

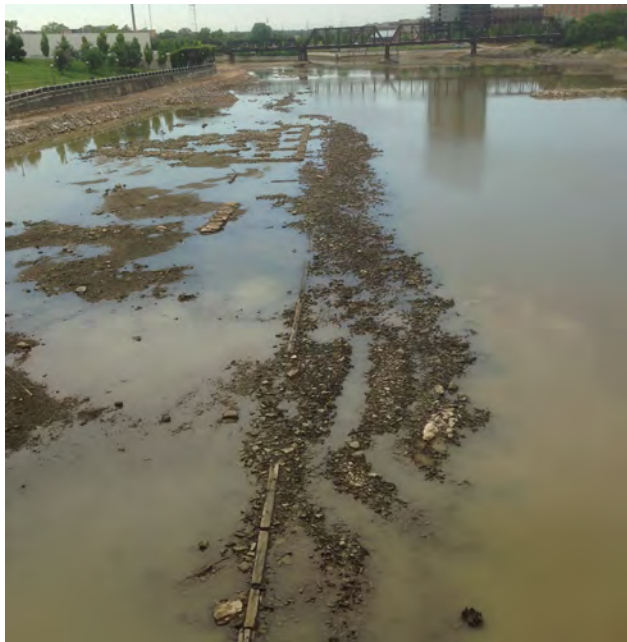
Buggy Company were found just upstream of the Broad Street (US 40) Bridge. Coordination with the State Historic Preservation Office (SHPO) required that additional research and archaeological work be done before working in the river in this specific area. The team mapped the stone and timber foundations, found barrels, bottles, and electrical artifacts, and thoroughly catalogued the site.

Historic building foundations found after dam breach in Scioto River.

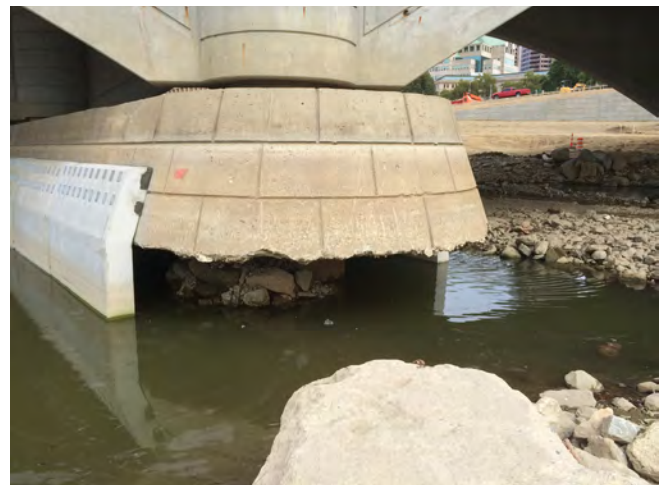
The precast panel installation progressed smoothly along the straight segments of the pier caps, but because the existing ends of the pier caps were angled and rounded, precasting and connecting the end panels became very difficult. The sequencing of the project pushed this task toward the end of construction, also making time a critical factor. The team went back to work and developed an aesthetically pleasing combination cast-in-place and pre-cast solution that allowed the contractor to quickly get the end segments placed and connected.

Skirting the pier caps proves difficult to angle and curvature.

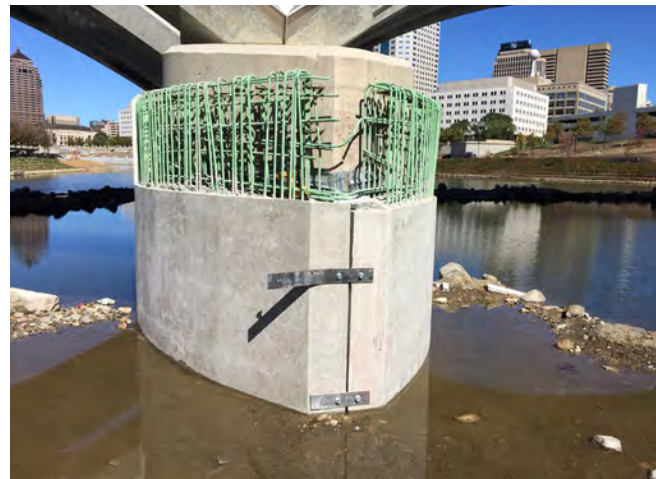
Bridge skirt installation

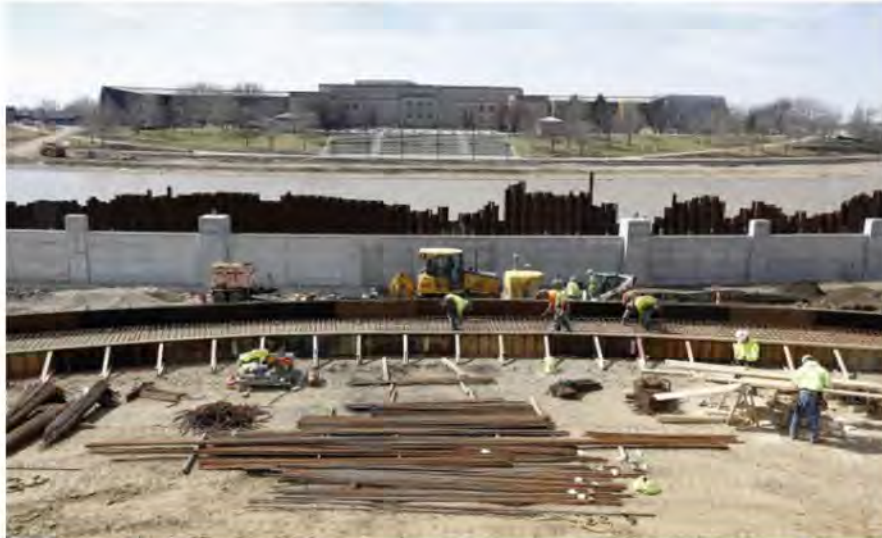
The \$35.5 million Scioto Greenways project includes the 700-foot concrete retaining wall, which not only will hold in the Scioto River but also serve as the base for the lower riverwalk, which will bring visitors closer to the waterfront. Crews will create 33 acres of green space and put in 800 trees and 75,000 plants this year.
